HIGH ARCH BRIDGE:
A COST BENEFIT ANALYSIS OF PRESERVATION TECHNIQUES AS APPLIED
TO A VERNACULAR CONCRETE STRUCTURE

Ann Marie DiLucia

A THESIS

1998

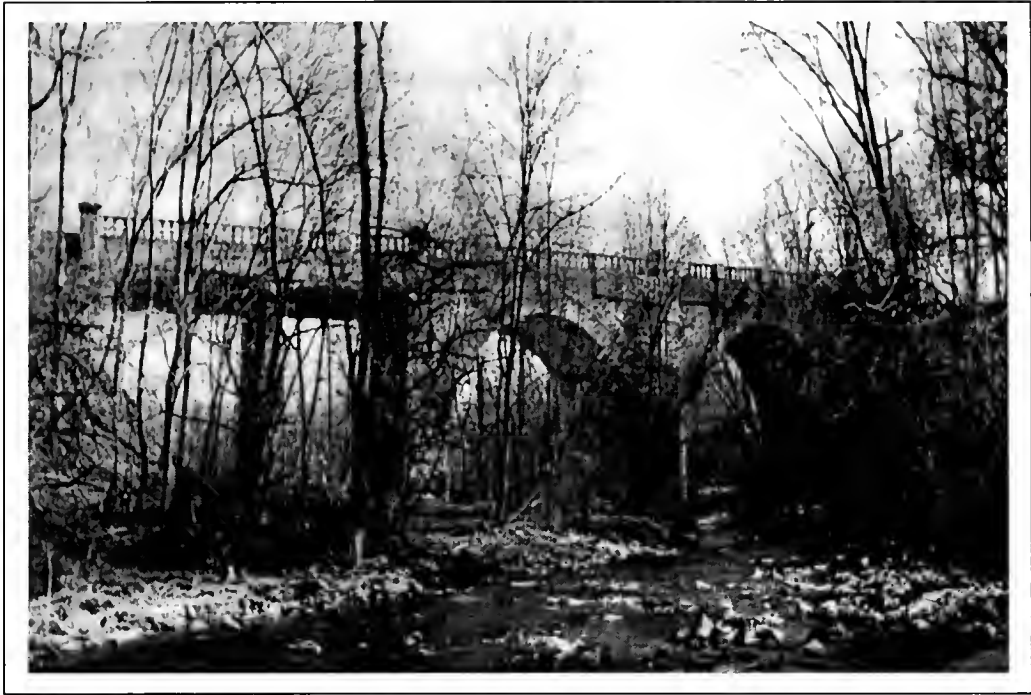
Observation of existing conditions reveals heavy losses of surface material, cracking, spalling, salt damage, and the effects of advanced freeze thaw cycling. The top portion of an abutment has crumbled away, and pieces of decorative elements lie in the creek below. Growth of a floodplain forest partially obscures view of the bridge from below, and vines have embedded themselves in another, still intact, abutment. Salt rings and water stains caused by drainage pipes cover the surface of the interior arches.

Figure 1 High Arch Bridge, west face.

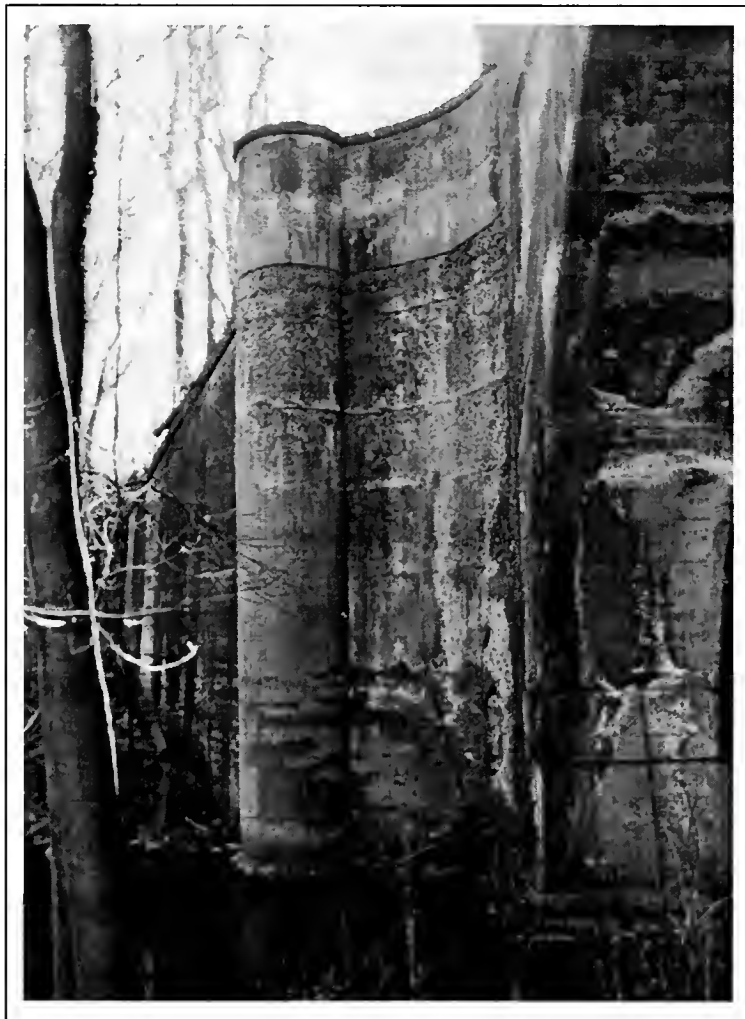
Figure 3 Southeast pylon.

The northeast pylon is no longer in place, exposing a vertical strip of two inch to ten inch mixed aggregate. The top 14' of the northwest pylon is gone, leaving behind an area of impressive overgrowth and bird's nests. A parapet on the deck of the bridge contains eight large and eighteen small posts, evenly spaced amidst 180 balusters (Figure 4).

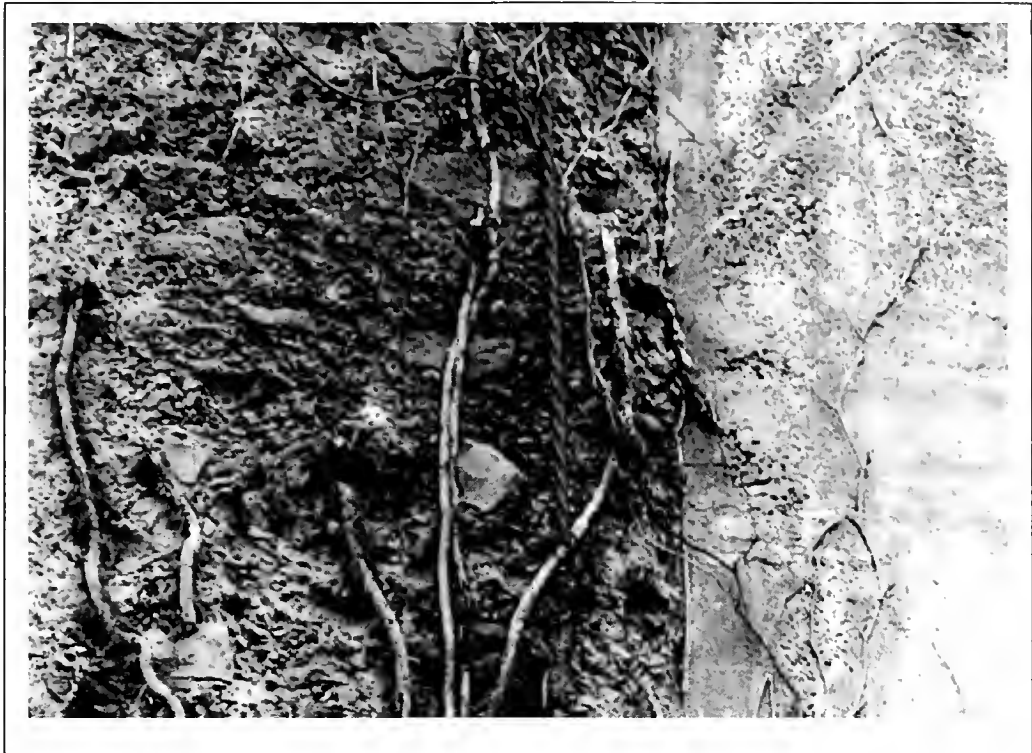
Figure 6 Deformed steel reinforcement projects from east pier face.

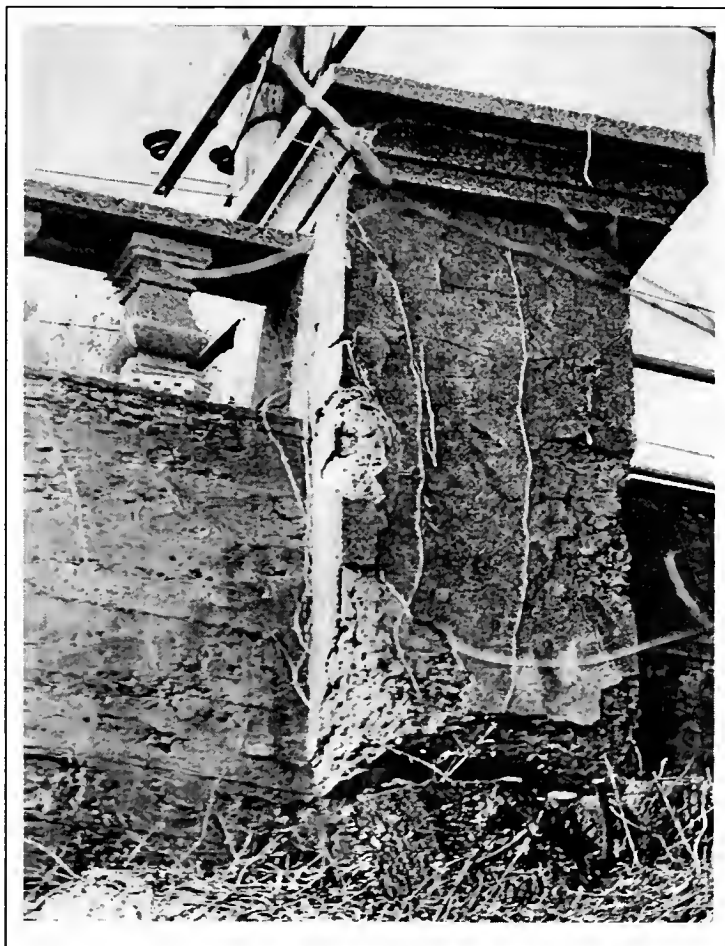
Figure 8 Loss of skim coat on balustrade post.

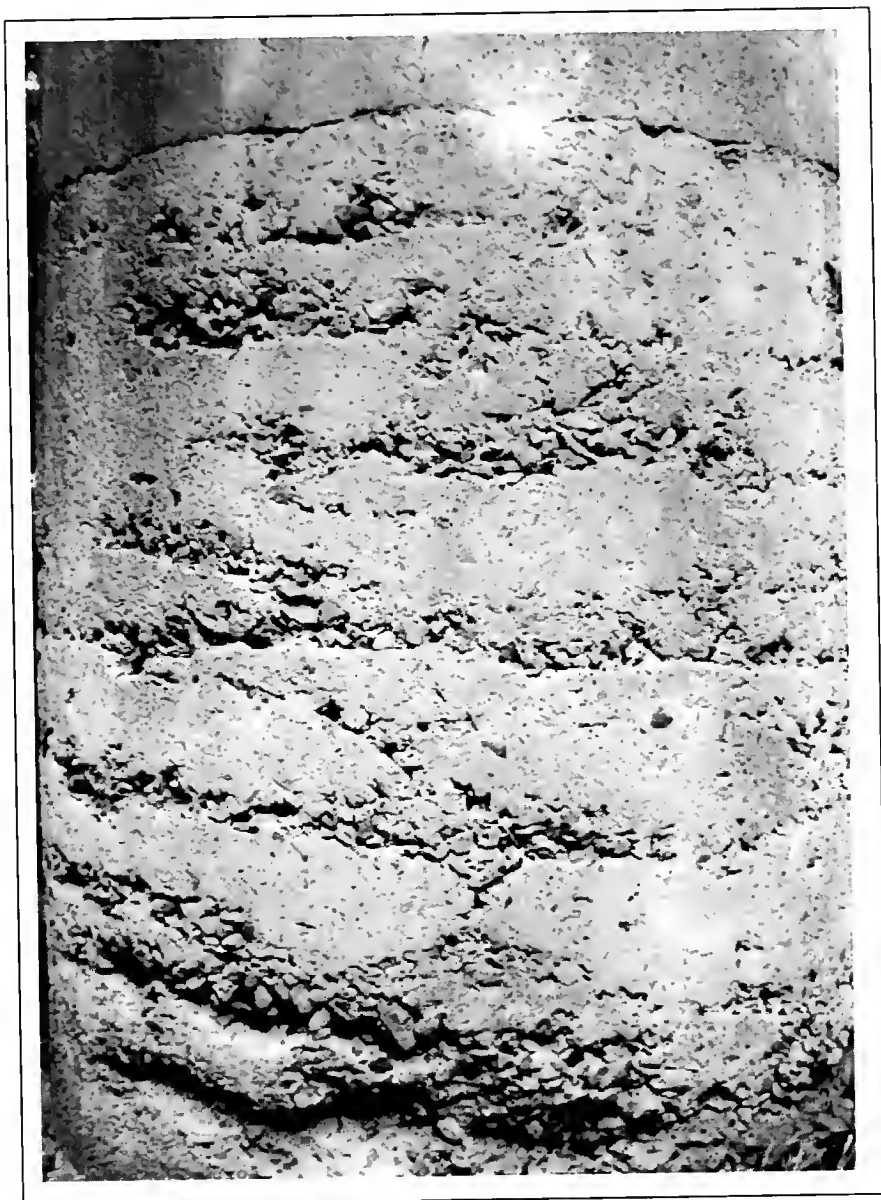
Figure 9 Honeycombing evident on northwest pylon.

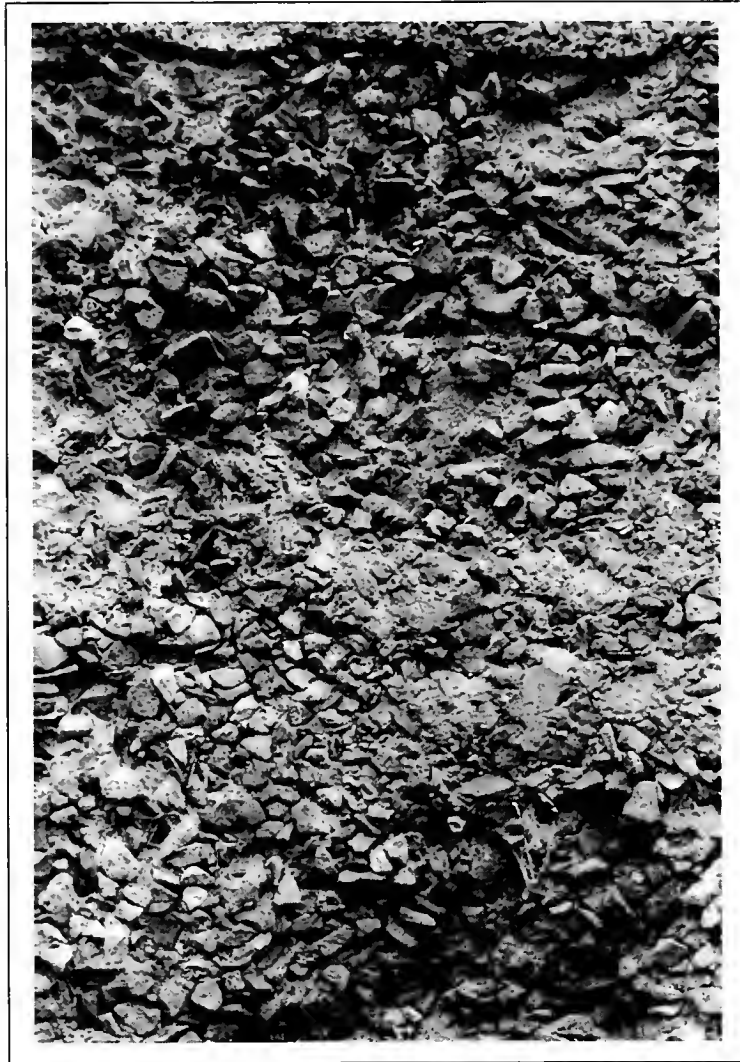
Material loss, the prevalent and most dramatic manifestation of concrete failure on the bridge, is attributed to man made and chemical influences. Seventy percent of the total surface area of the bridge exhibits losses ranging from one half inch to as deep as seven inches. Shallow losses surround the east and west faces of the vaulted arches, and the upper portion of both interior arches. Loss of the skim coat is visible on several balustrade posts (Figure 8), and on the north and south abutments. Honeycombing of material in the pour process is most evident in the pylons (Figure 9). Exposed aggregate caused by binder loss is visible on twenty percent of the total surface area (Figure 10).

Figure 10 Exposed aggregate on west wall.

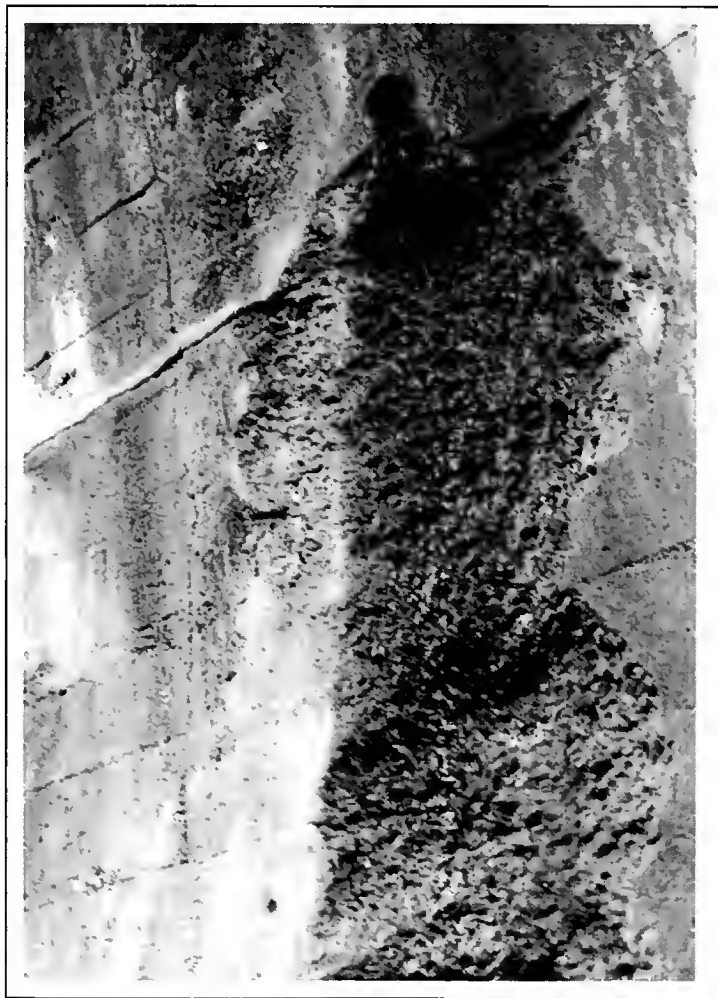
Deep losses are present on thirty percent of the structure, the result of several mechanisms. Two to four inch losses are found on the interior walls of both arches and are the result of weephole drainage (Figure 11). These surfaces are never dry, and

Figure 11 Loss to surface caused by weephole design.

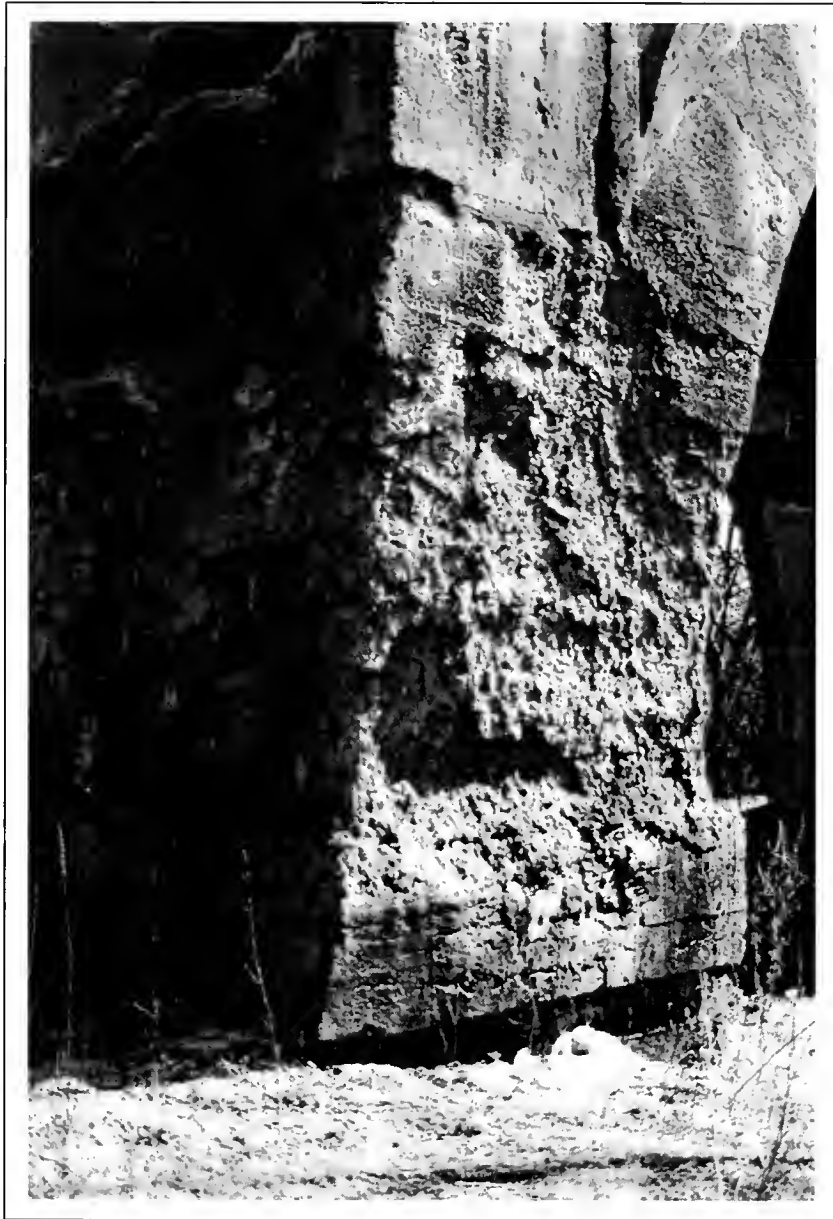
several of the weepholes drip constantly. The effects of freeze thaw cycling and erosion have resulted in extreme losses to Pier 1 (Figure 12). All faces of the pier display scaling to seven inches below the surface, with the area of loss extending to a height of ten feet above ground level. Weathering has caused all hard edges and angles on this pier to wear away.

Figure 12 Extreme loss to Pier 1, west side.

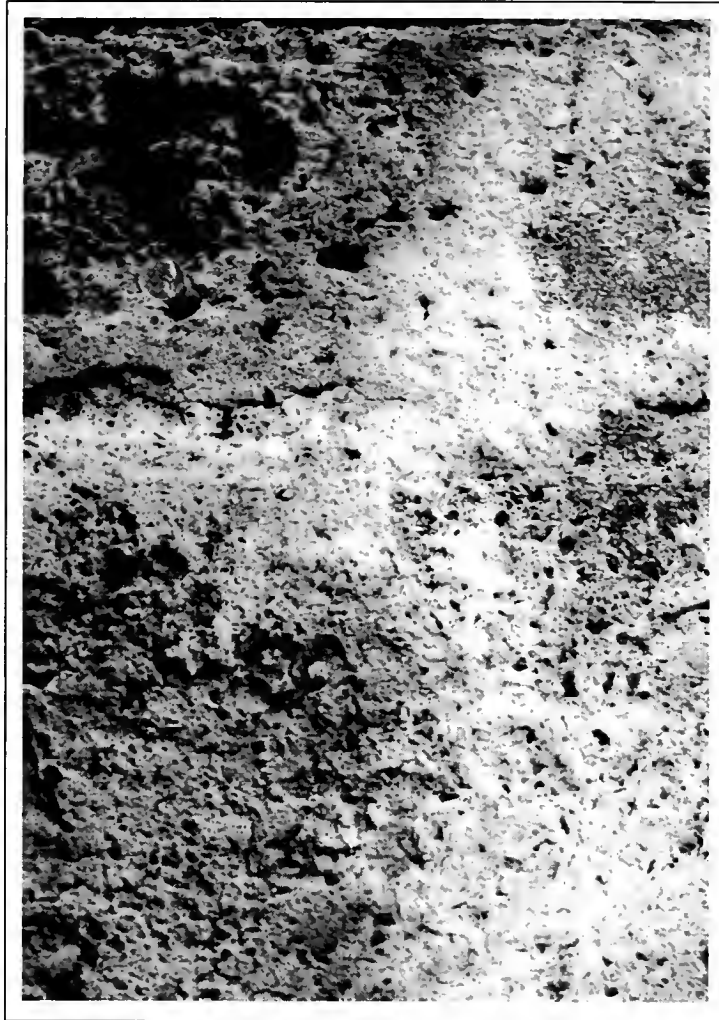
efflorescence and subflorescence. Heavy buildup of salts on the surface indicates large quantities present in the substrate (Figure 13).

Figure 13 Salts on surface of interior arch wall.

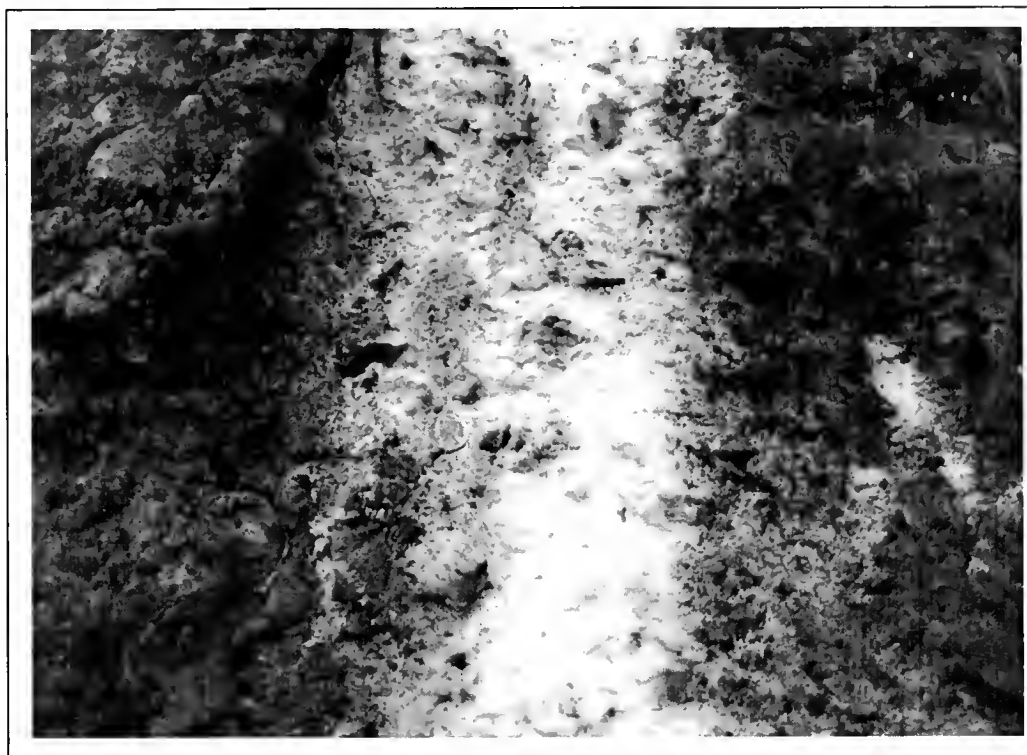
Further evidence of salts are found in the form of gypsum crusts clinging to the areas of loss on the arch interior walls mentioned above (Figure 14). Stalactites cling to the I-beams in the straight spans, emphasizing the action of salts within the deteriorating material.

Figure 14 Gypsum crusts evident around drainage area.

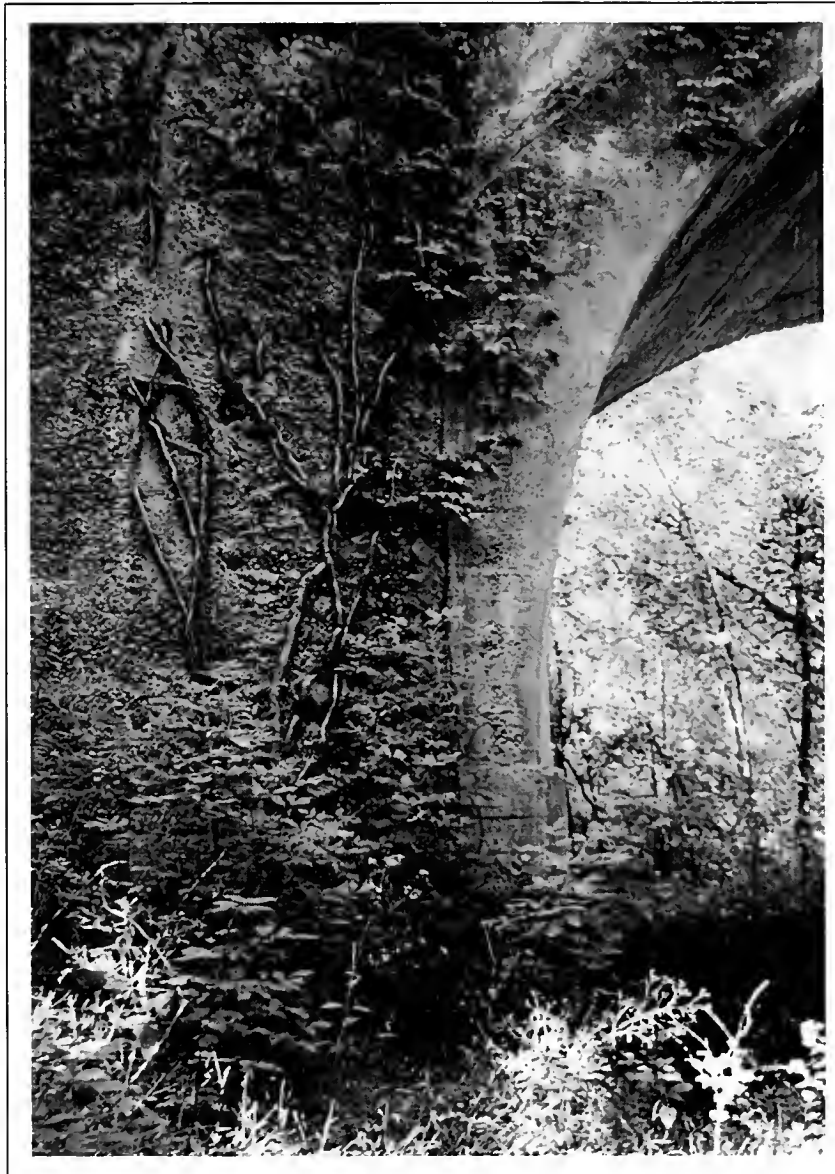
Biological growth and vegetative infestation are present on approximately forty percent of the bridge. It is manifest in the form of green material on the east face of the bridge and throughout the parapet. Lichens ranging in color from dark green to brown are prevalent on the lost areas of Pier 1. The most notable instance of vegetative overgrowth is found on the east face of the second pier in the space formerly occupied by a decorative pylon. Vines and small tree roots are here embedded in the substrate (Figure 15). The pylon on the west side of the bridge, its top 14 feet gone, is also overgrown with tall grass and small trees (Figure 16).

Figure 15 Extreme vegetative overgrowth, Pier 2.

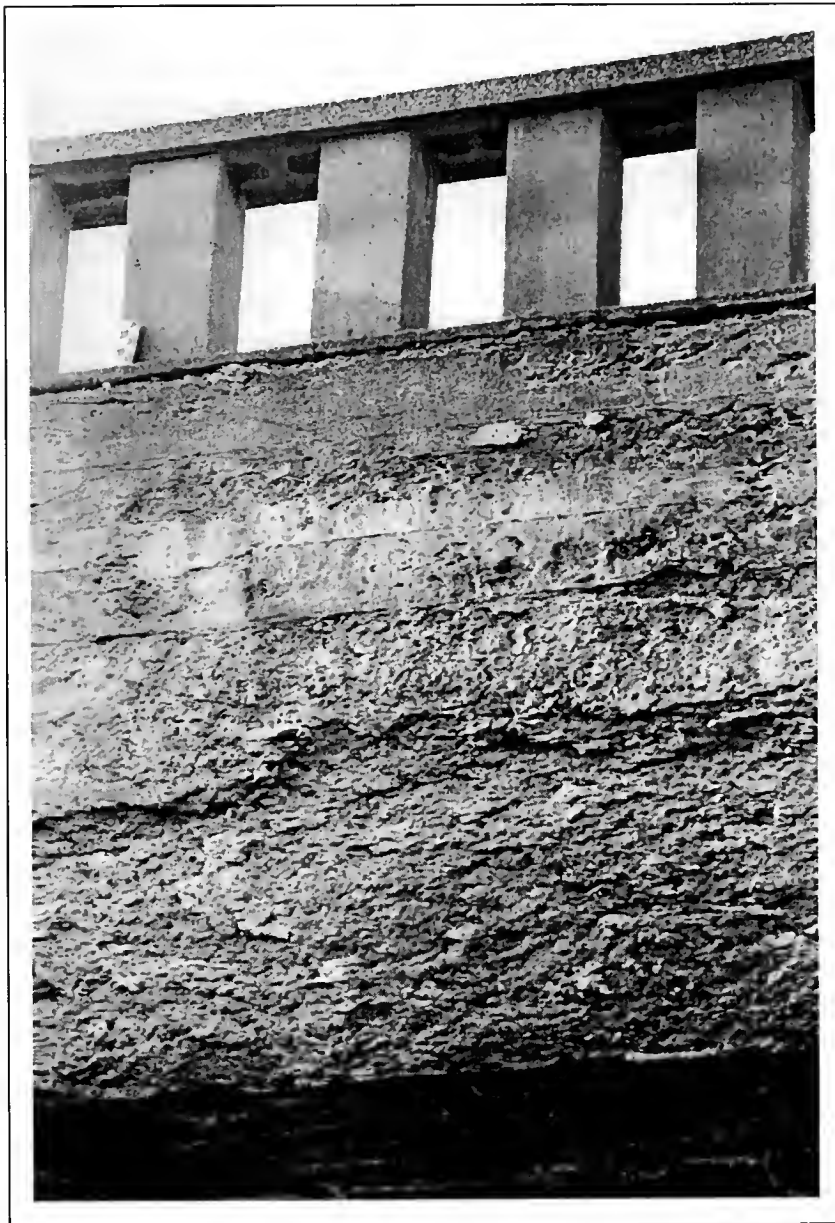
Finally, previous repair campaigns have created inconsistencies in the balustrade. Decorative balusters have been replaced in several areas with nine inch rectangular supports, an unfortunate circumstance causing aesthetic disharmony to the overall appearance of the bridge (Figure 16). In other sections of the balustrade, voids exist where no attempt was made to replace lost balusters (Figure 17). Integrity of the fabric and safety of the structure are jeopardized by these losses.

Figure 17 Rectangular replacement balusters

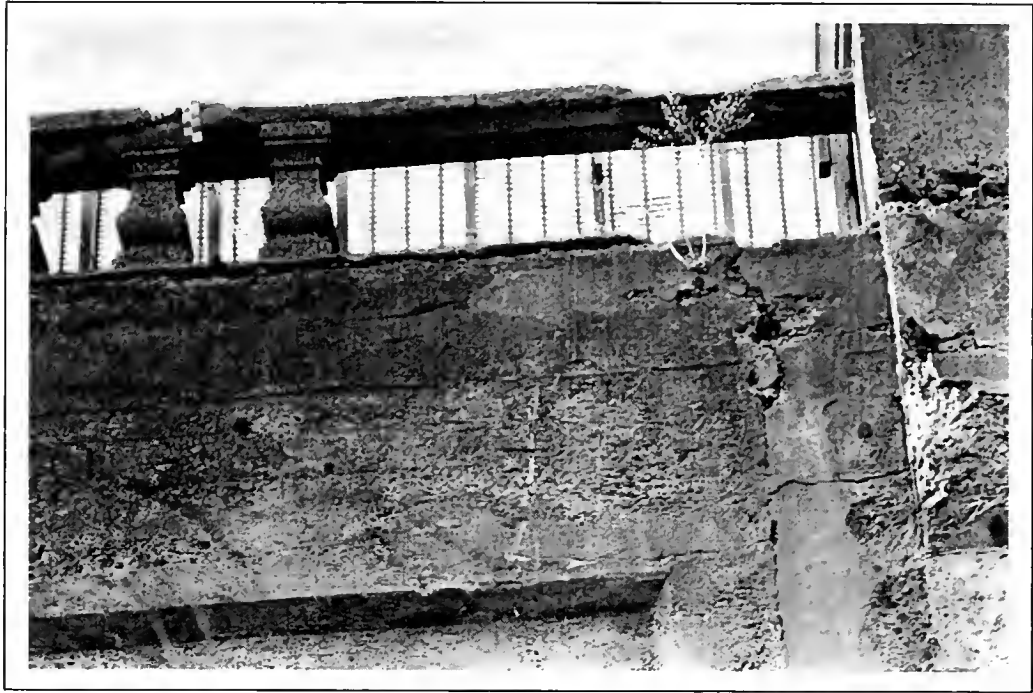
Figure 18 Voids in balustrade.
